Disablement Testing of 1981-1982 Model Year Vehicles with Closed-Loop Emission Control Systems

1. REPORT NO. EPA-AA-TSS-82-5	2.
3. RECIPIENT'S ACCESSION NO. PB83 144568	
4. TITLE AND SUBTITLE Disablement Testing of 1981-1982 Model Year Vehicles with Closed-Loop Emission Control Systems.	5. REPORT DATE September 1982
	6. PERFORMING ORGANIZATION CODE
7. AUTHOR(S) R. Bruce Michael	8. PERFORMING ORGANIZATION REPORT NO.
9. PERFORMING ORGANIZATION NAME AND ADDRESS U.S. Environmental Protection Agency Office of Mobile Source Air Pollution Control Inspection and Maintenance Staff Ann Arbor, MI 48105	10. PROGRAM ELEMENT NO.
	11. CONTRACT/GRANT NO.
12. SPONSORING AGENCY NAME AND ADDRESS Same as box 9.	13. TYPE OF REPORT AND PERIOD COVERED Technical
	14. SPONSORING AGENCY CODE
15. SUPPLEMENTARY NOTES

EPA-AA-TSS-82-5

R. Bruce Michael

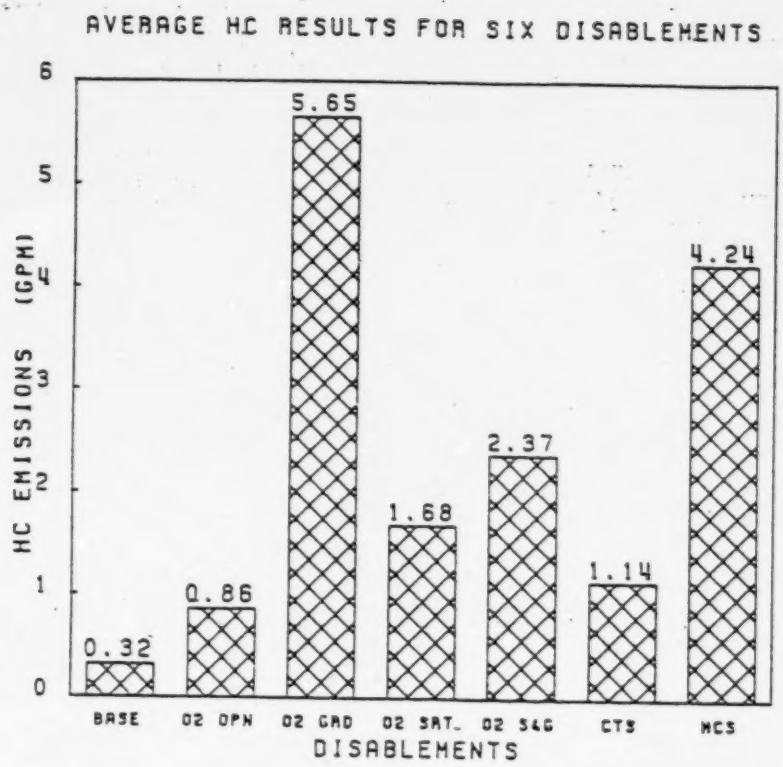
Figure 1

Table 4 presents the average Federal Test Procedure (FTP) emission and fuel economy results for each specific condition. Baseline results are also shown for each condition. Figures 1 and 2 show bar charts of the HC and CO levels for several specific conditions.

AVERAGE HC RESULTS FOR SIX DISABLEMENTS
HC EMISSIONS (GPM)
0
1
2
3
4
5
6
0.32
0.86
5.65
1.68
2.37
1.14
4.24
BASE
02 OPN
02 GRD
02 SAT.
02 SAG
CTS
MCS
DISABLEMENTS

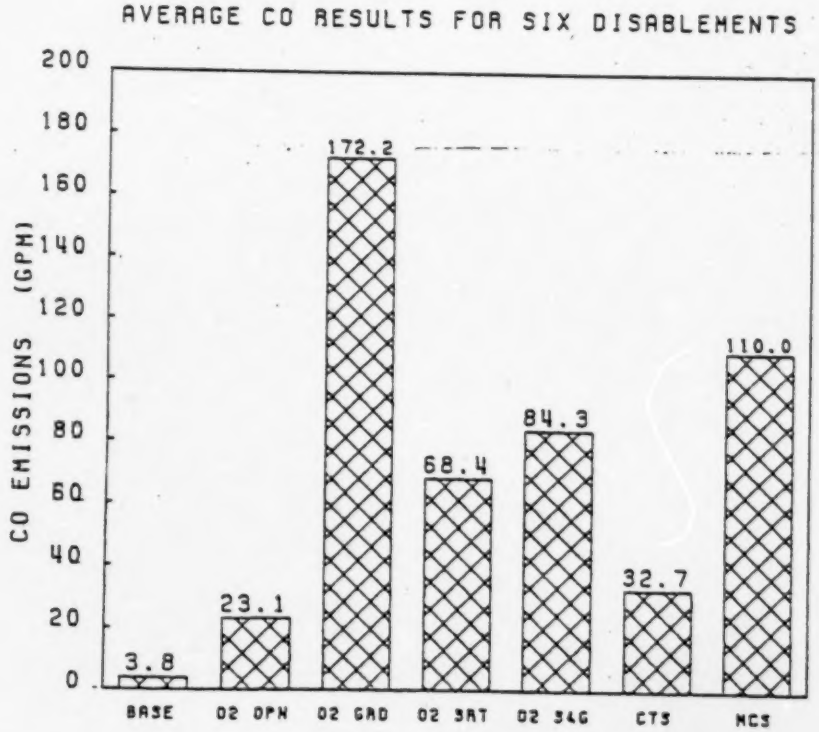
Figures 1 and 2

AVERAGE CO RESULTS FOR SIX DISABLEMENTS
CO EMISSIONS (GPM)
0
20
40
60
80
100
120
140
160
180
200
3.8
23.1
172.2
68.4
84.3
32.7
110.0
BASE
02 OPN
02 GRD
02 SAT
02 SAG
CTS
MCS
